Test Report No.SDHL2208017023FT

FOSHAN LEISURE TOUCH FURNITURE CO., LIMITED

: BRUSHED ALUMINUM

ISO 9227:2017 Corrosion Tests in Artificial Atmospheres — Salt Spray Tests.

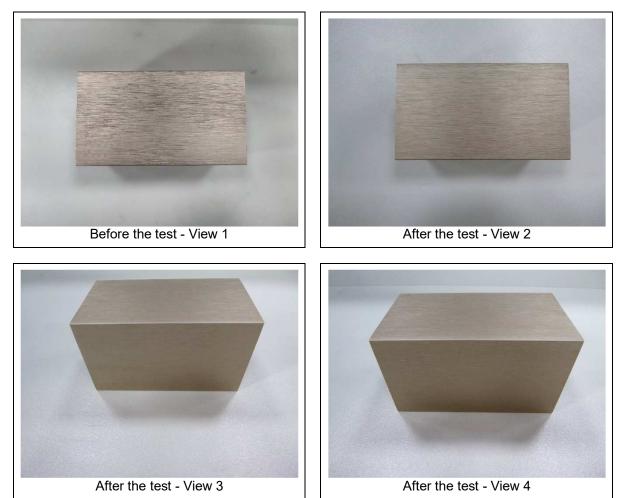
Pictures of Salt Spray Tests

| 1. General Information: | | | | | |
|---|--|---|--|--|--|
| # 1 | Grade 10 | | | | |

1 piece (Sample #1). For more sample information and pictures, please refer to the following page.

1. For the sample pictures, please refer to the following page.
